## GAB BIODIVERSITY SURVEY OF SG. WAY

**Date** : 5 March 2008  
**Team member** : Balu Perumal, Azli Abu Bakar & Regina Cheah  
**Subject** : Flora report from the recce trip

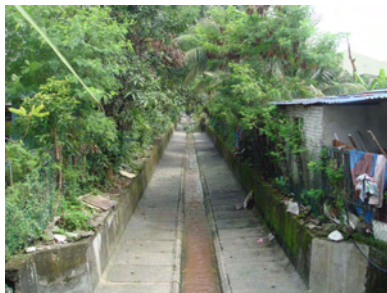
This section consists of a network of smaller drainage systems (< 2 ft deep) that form part of the SS9 housing estate that flows into two larger drains (4 - 6 ft deep) which eventually joins into a much larger drainage canal (8 - 10 ft deep) forming the main Sg. Way River that flows under and across the Federal Highway.

*Figure 1: Drain between SS9/5 and SS9/7*

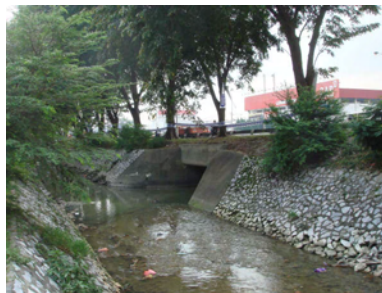
*Figure 2: One of the 'arms' of Sg. Way*

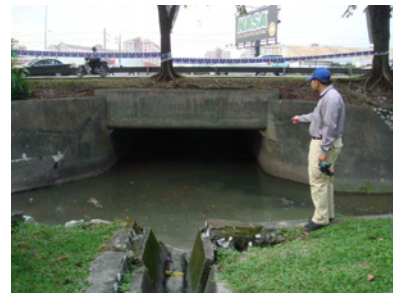
*Figure 3: Meeting point of the 2 arms before crossing Federal Highway*

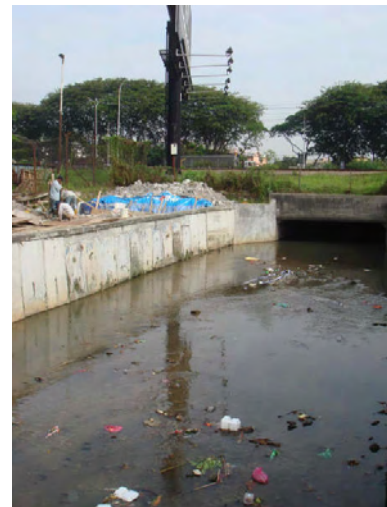
Aquatic vegetation: None observed within the drainage system. Water flow regular and uninterrupted with no sand deposits for vegetation to take foot-hold. A lot of solid waste from the housing area was observed. Also noted that effluent from GAB goes into the river.

Figure 5: Solid waste observed in the river

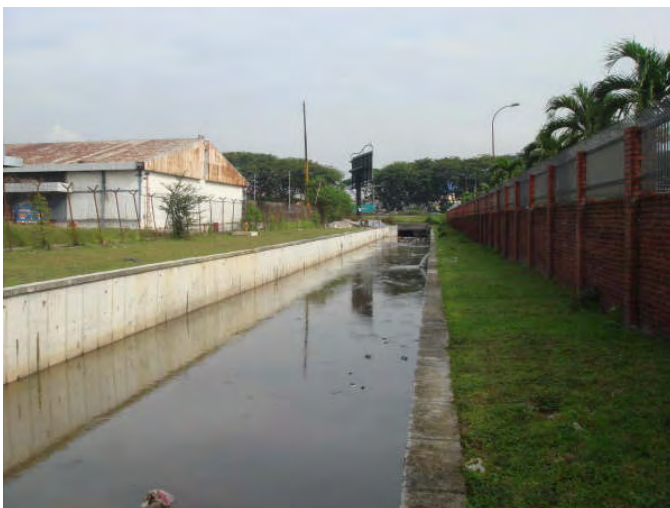
This section runs alongside GAB with the river cutting across the industrial area up until the road facing the ESSO and PETRONAS petrol stations.

Figure 4: Sungai Way flows next to GAB

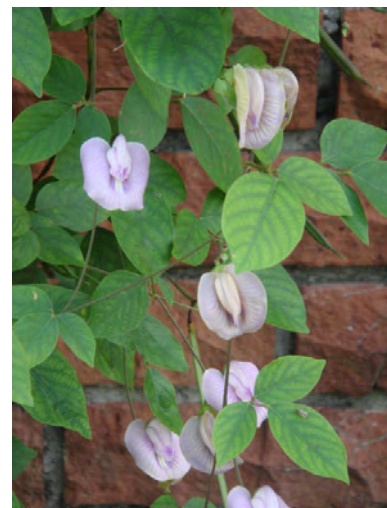
Figure 6: Blue Pea Vines (*Clitoria ternatea*) can be seen growing along the walls

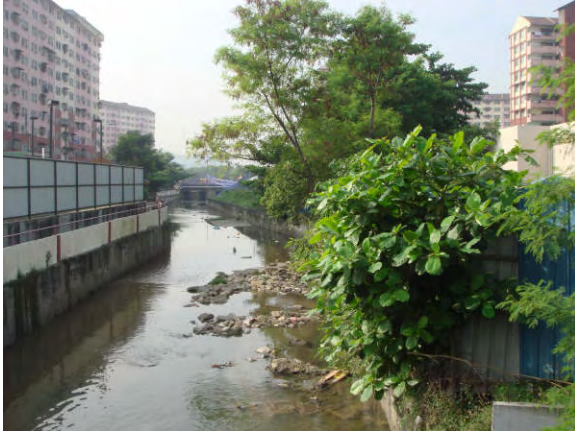
Part of this section has a paved walkway on one side of the river and on the opposite side (i.e. behind Esso Station and probably an old workshop), the area was left unattended and dominated by overgrown vegetation.

*Figure 7 (top left): View of the Sg. Way stretch along the Desa Mentari Flats*

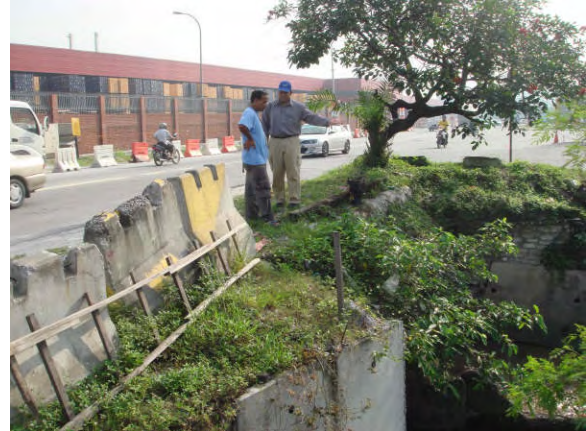
*Figure 8 (top right): Standing above Sg. Way as it flows between the 2 petrol stations*

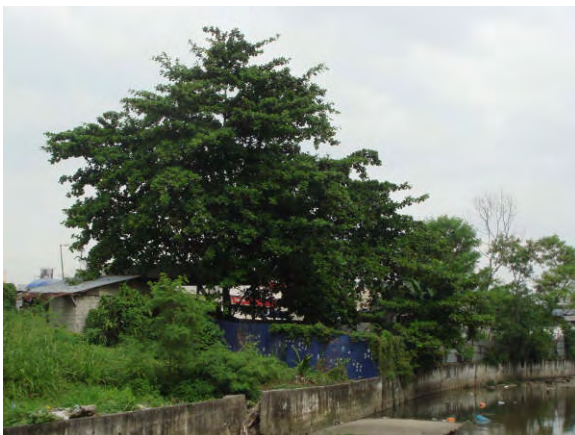
*Figure 9 (bottom left): The Indian Almond (Terminalia catappa) can be seen here along the bank of Sg. Way, providing shade and habitat*

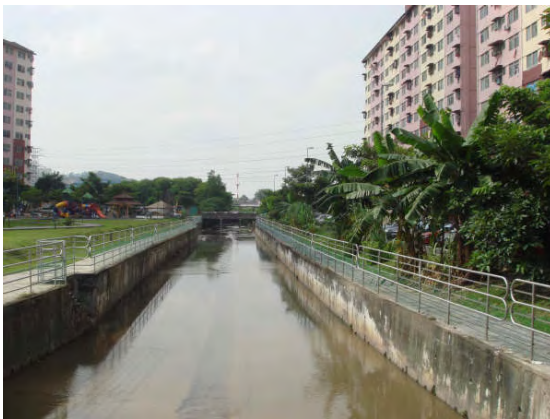
Interestingly, this section of the river has been fully concrete-channelized with walking pavements on either sides of the river and is fully fenced. There is a children's playground and a stretch of cultivated land area behind the housing flats.

*Figure 10 (top left): Looking upstream.  
The river is completely channelized*

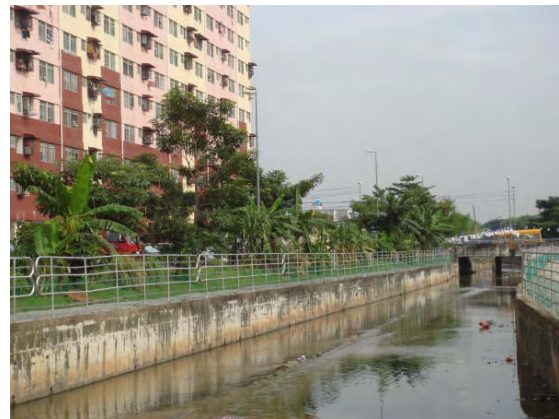
*Figure 11 (top right): Banana trees have  
been planted alongside the river*

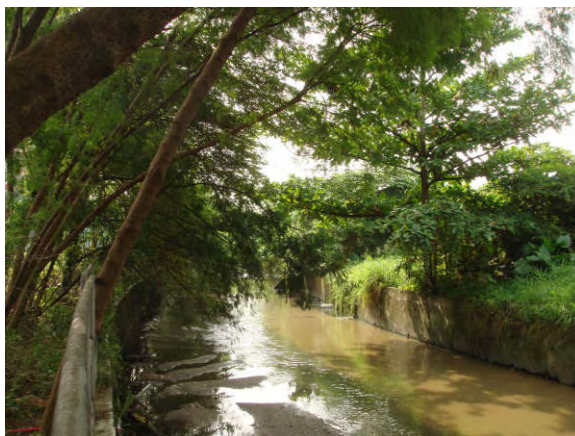
Figure 14: Many trees and shrubs form a natural environment for birds and other animals to thrive in

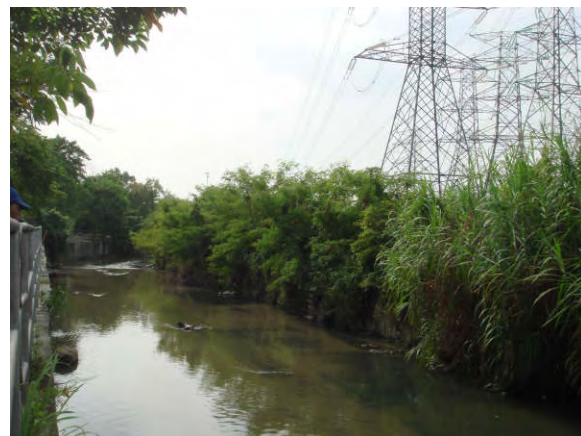
Aquatic plants: Few plant species observed taking hold on sand deposits along the river. Also noticed that many parts of the concrete river were broken and this allows the larger herbs and shrubs to take root at the river bed directly. A lot of creepers and climbers can be found along the river slopes/ banks.

Figure 15: Concrete banks are taken over by shrubs
